July 2004

Technical Series 04-118

PERFORMANCE OF SPRAYED POLYURETHANE FOAM ON INDOOR FOUNDATION WALLS

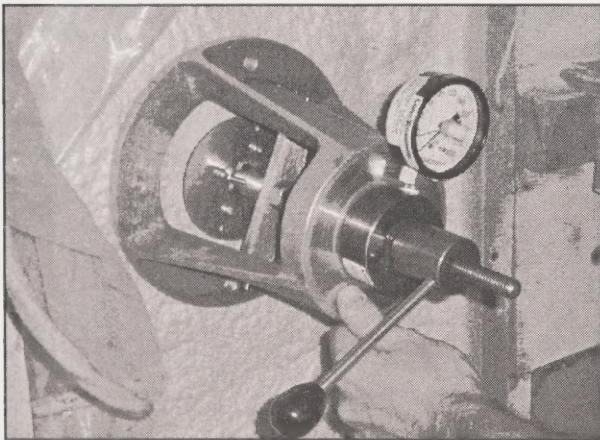
The device used displayed a reading on a dial, expressed in kg, of the tear strength force required to detach the insulation from the foundation wall.

Before the tests, a researcher knocked on all the accessible, insulated wall surfaces to check whether there might be any cavities behind the insulation and to determine the location of the adhesion test sites.
